<b>Test Report No: TJ6815</b>	<b>Date: November 26, 2019</b>
-------------------------------	--------------------------------

**SAMPLE ID:** The test samples are identified as “**Plastica Alfa ALFAIDRO NOFIRE System**”.

**TEST PROCEDURE:** UL 1821; Thermoplastic Sprinkler Pipe and Fittings for Fire Protection Service (Third Edition, 2015). Section 13, Fire Exposure Test.

**TEST RESULTS:** The sample **COMPLIES** with section 13.1.1 of UL 1821. Detailed test results are presented in the subsequent pages of this report.

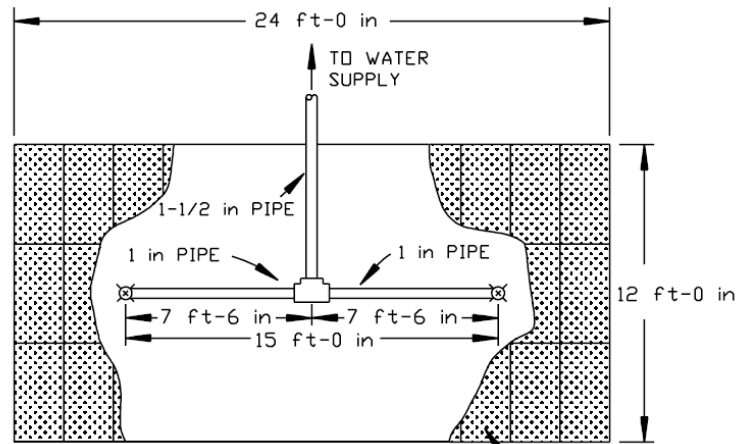
**Tubing Detail:** The tested branch configuration included 7.5 feet of 1 ½ inch Plastica Alfa ALFAIDRO NOFIRE System, from supply to the tee and two 7.5 feet long sections of 2 inch Plastica Alfa ALFAIDRO NOFIRE System from both ends of the tee. One hanger was used for each branch line and one at the center tee fitting. See Figure 1 for detail.

**Sprinkler Detail:** Two Victaulic Firelock™ Model V3426 Pendant Sprinkler, K6.9, Quick Response 155°F were used in the tested assembly. Sprinkler One is indicate on the left of the below schematic and Sprinkler Two is indicated on the right.

Figure 1. Branch Detail per figure 13.1 of UL 1821

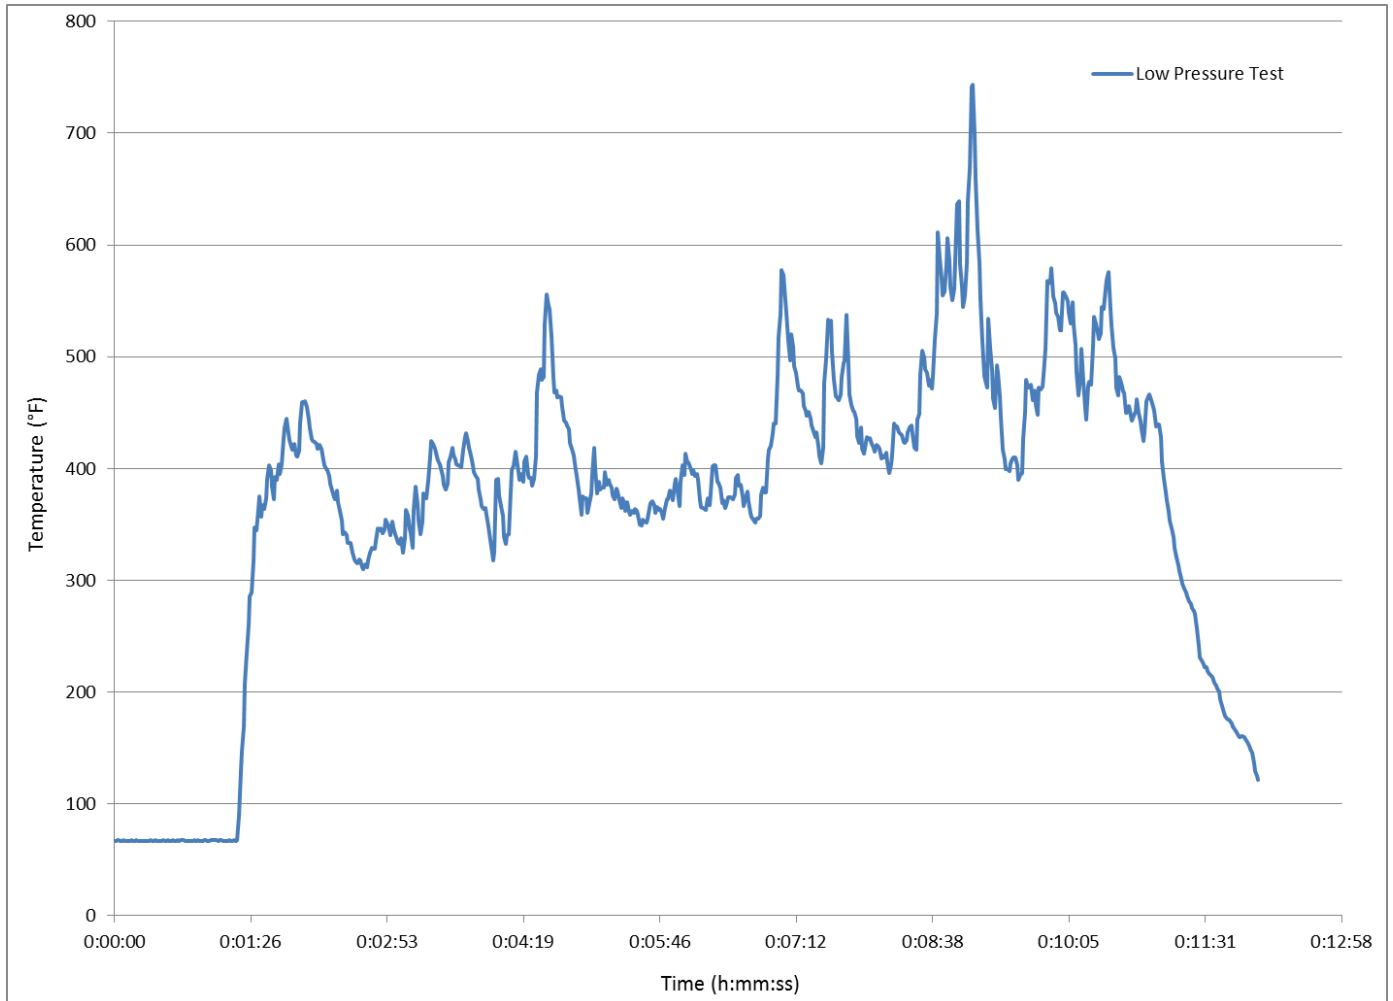
One single thermocouple was placed directly over the heptane pan in the centerline of the test configuration. The data generated is displayed below.

**Figure 2. Temperature Profile for Test One**

Static Pressure in Piping Configuration:	<b>120 psi</b>
Flow from both sprinklers:	<b>45 gpm</b>
Time of Sprinkler 1 Activation (after heptane ignition):	<b>0:44</b>
Time of Sprinkler 2 Activation (after heptane ignition):	<b>0:51</b>

During Test One, the piping assembly did not burst, separate or leak and maintained the sprinkler in the intended operating position

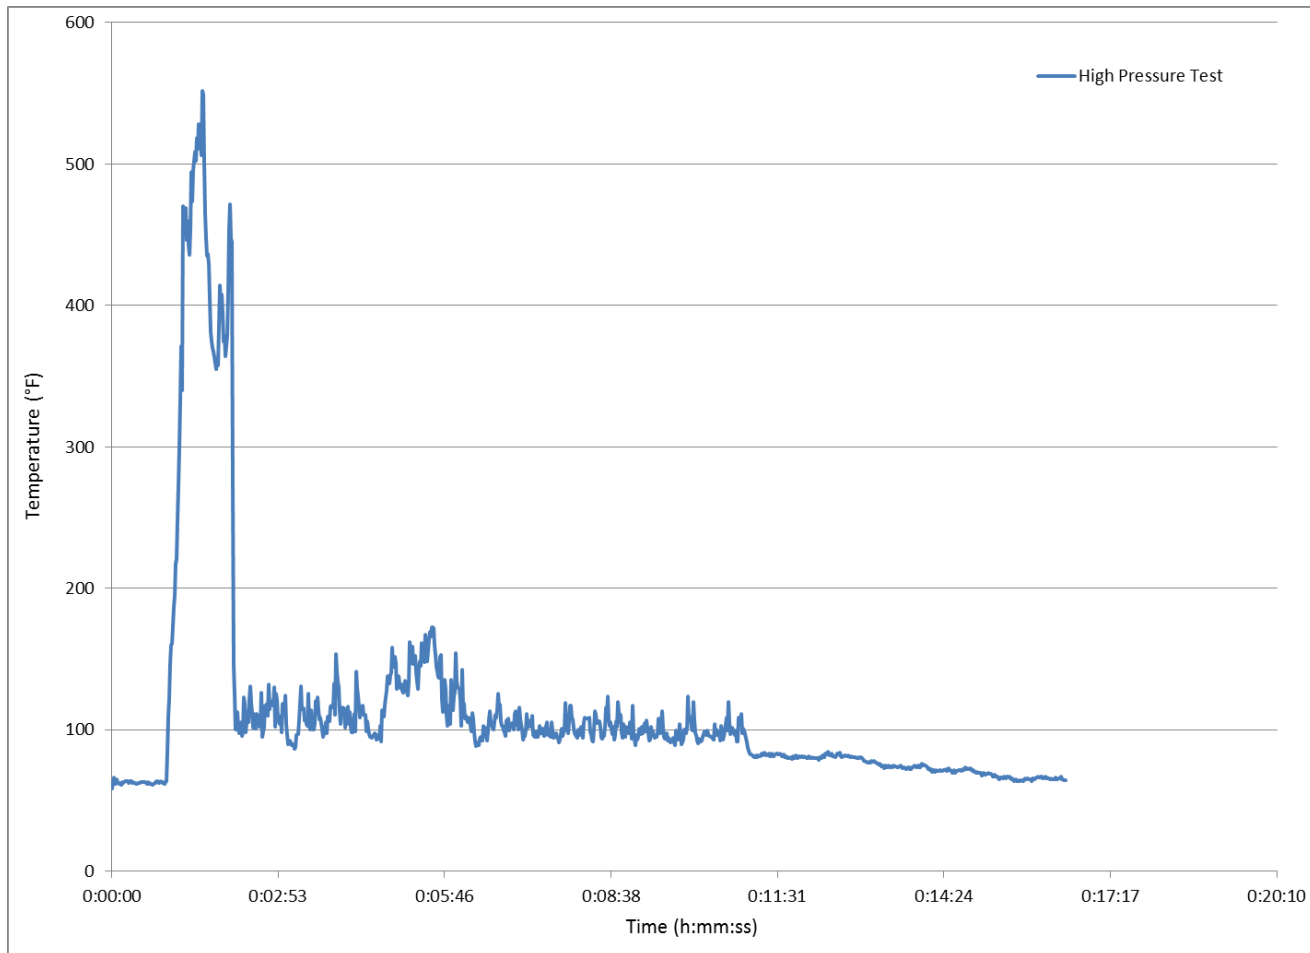
**Figure 3. Temperature Profile for Test Two**

Dynamic Pressure:	<b>161 psi</b>
Flow from both sprinklers:	<b>141 gpm</b>
Time of Sprinkler 1 Activation (after ignition):	<b>1:08</b>
Time of Sprinkler 2 Activation (after ignition):	<b>2:51</b>

During Test Two, the piping assembly did not burst, separate or leak and maintained the sprinkler in the intended operating position.

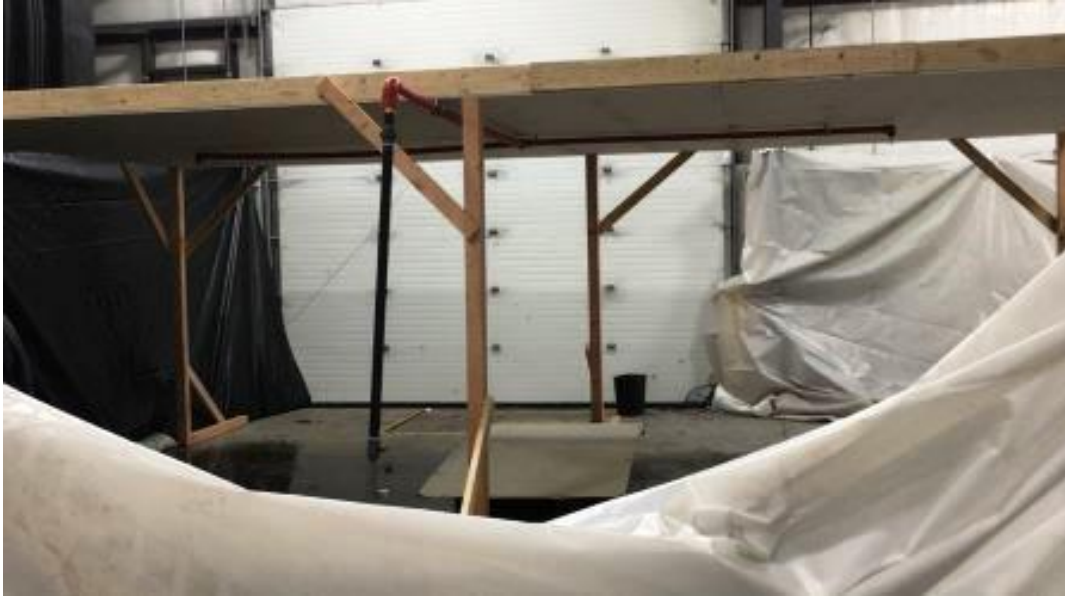
**Configuration of Test One**

The ceiling of the assembly was built per Section 13.1.6. The ceiling was constructed using gypsum wallboard meeting the dimensional details of the Standard. Please see Photos section for detail.

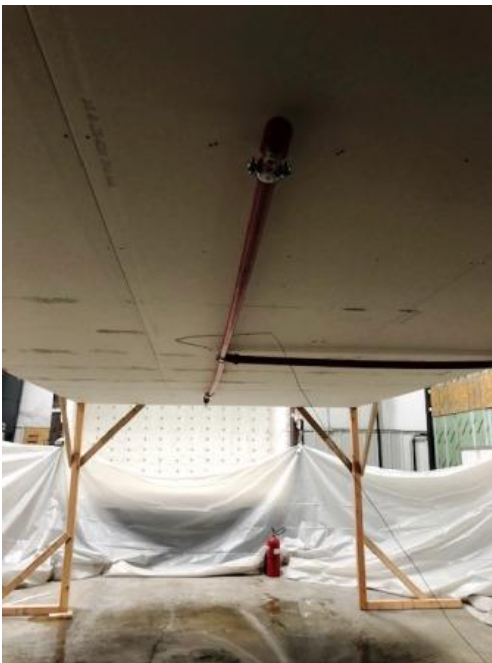
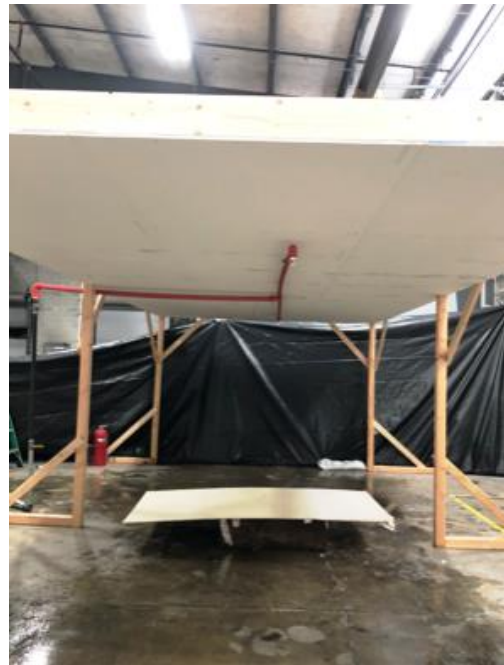
**Configuration of Test Two**

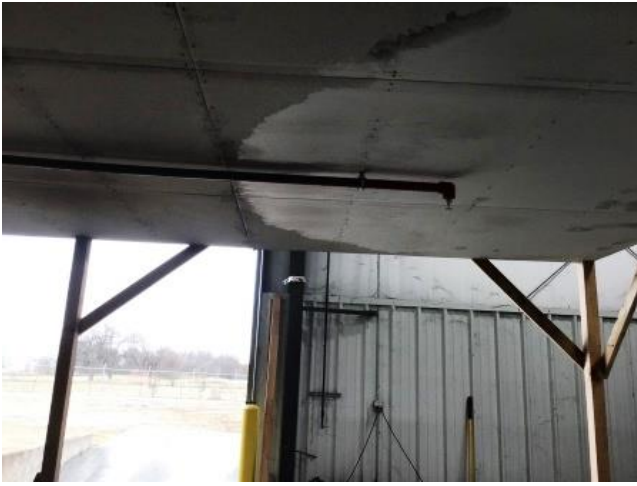
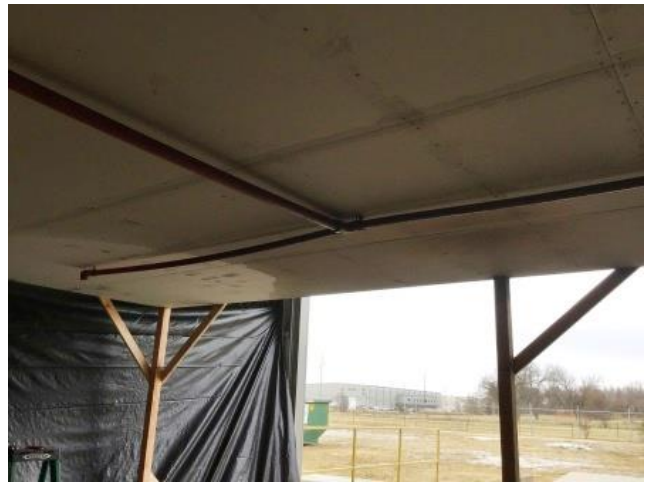
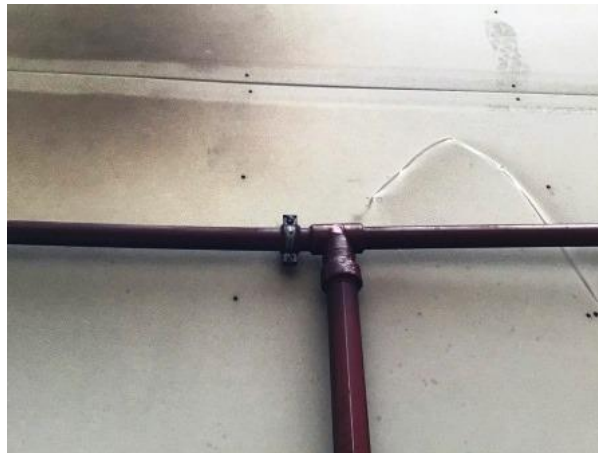
**PHOTOS: Test Configuration One– AFTER TEST:**

**Test Configuration One**

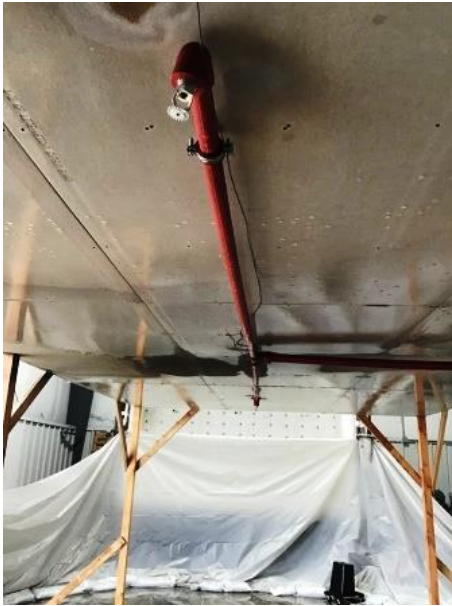
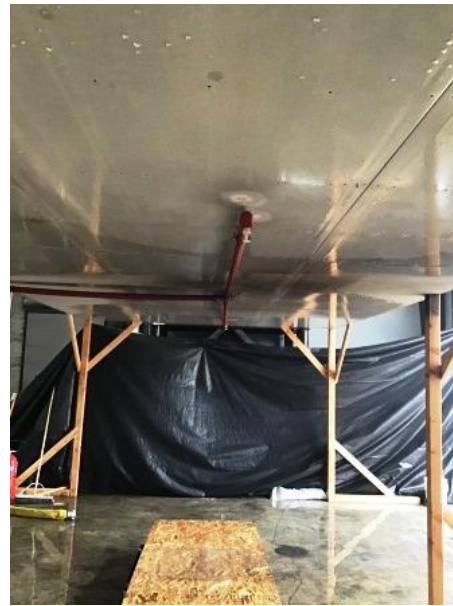
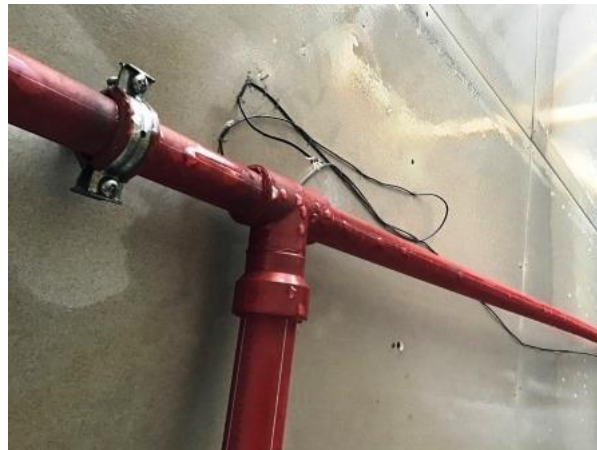
**PHOTOS: Test Configuration Two– AFTER TEST:**

**Test Configuration Two**

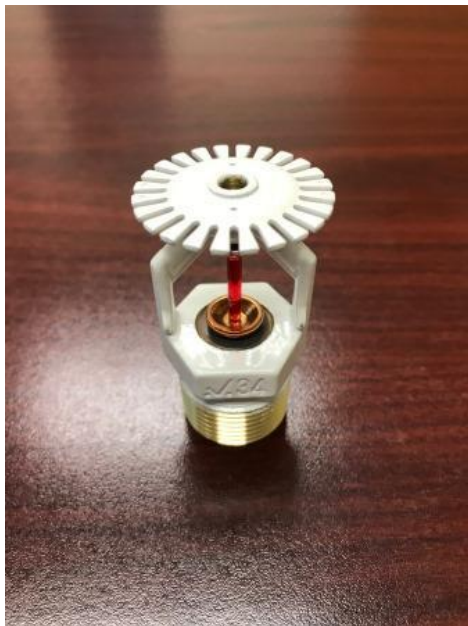
Sprinkler Used

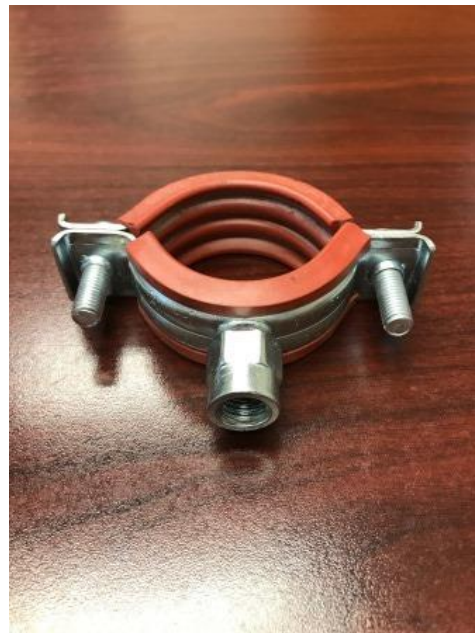
Hanger Used
