# ShandDong Buoy&Pipe Industry Co.Ltd.

Australia Distributor PBA CASE STUDY – RESOURCE EQUIPMENT LIMITED/PEABODY

## UHMWPE(ultra high molecular weight pe)pipe project cases

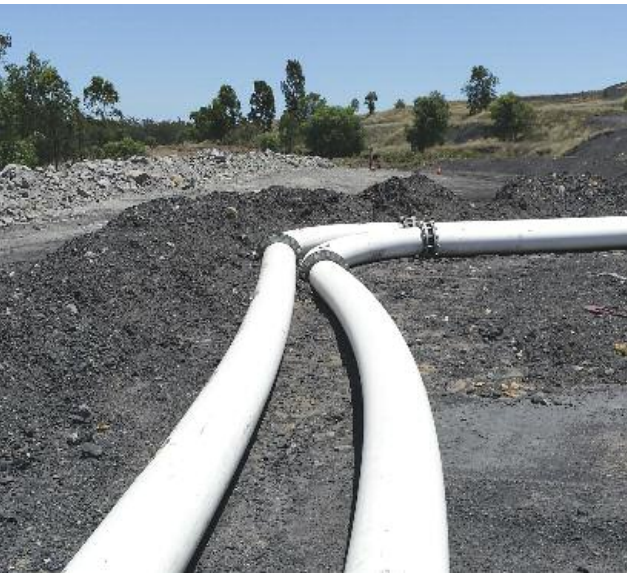
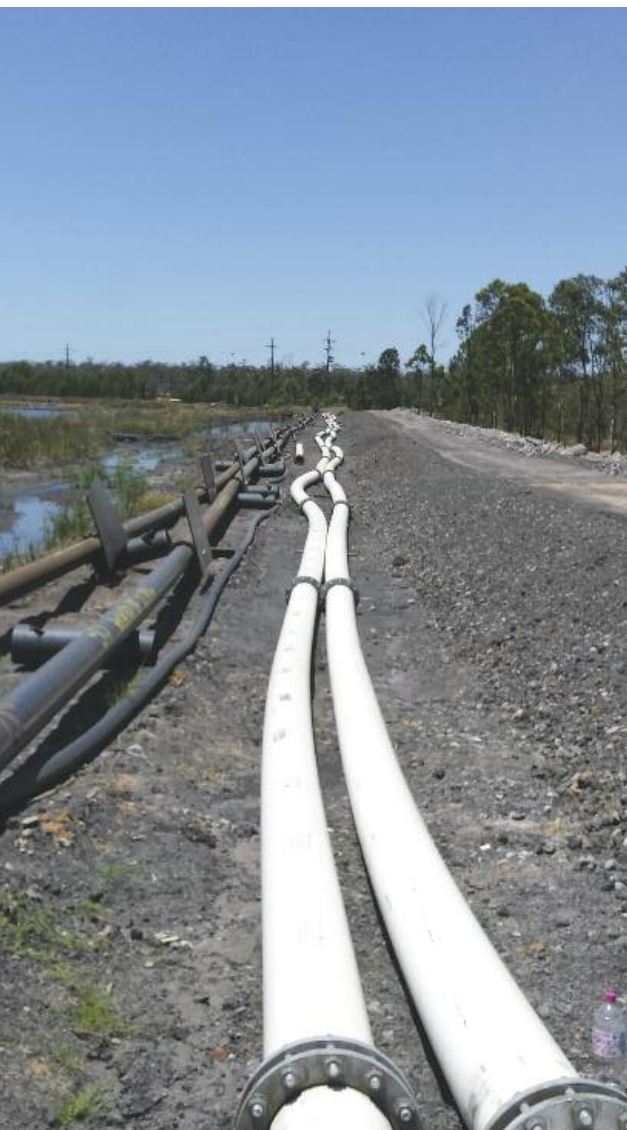
Client:	Resource Equipment Limited / Peabody
Location:	Coppabella CHPP
Pipe Size:	250 ID WT30
Qty:	~1.5km – 2 lines
Connection Type:	Stub flange – Table E
Date of Purchase:	August 2014
Date of Install:	October 2014

Process Type / Service:	Co-disposal tailings slurry
Solid Size:	30% of solids > 50mm, up to 200mm
Density / Composition:	50% w/w
Flow / Velocity rate:	4.2 m/s
Total Dynamic Head:	10 - 14 bar at pumps
Wall thickness:	Testing 3 - 4 mm net wear loss per month (tested fortnightly) in straight sections. 8mm net wear loss per month (tested fortnightly) in sweeps 12mm net wear loss per month (tested fortnightly) in bends. Average of 1.5 - 2mm per line for straight section. Minimum of 450 points of testing per visit.

The wear loss exhibited is similar to that of Hardened Steel. Our product being 30mm thick and the “extra strong” 250ID Steel being 12.7mm means we have a lot more wall thickness to play with prior to requiring rolling. Both being similarly priced.

Should this be managed properly, the average lifespan of pipe will be 3 years (for both lines) – rather than the 1.5 years attributed to Steel.

The wear rate is exacerbated greatly in areas of severe misalignment
